Manhole Inspection Summary

Manhole # S41Y1_020MH

Location Address: **3700 Pontiac Ave**

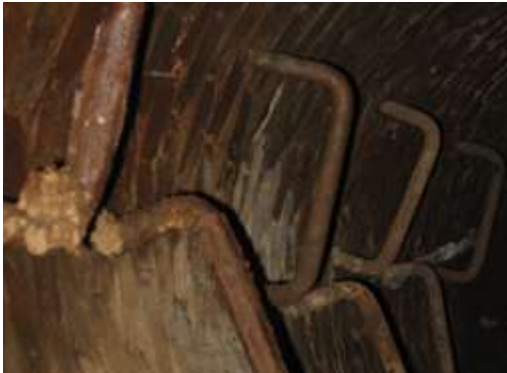
Defect 2

steps

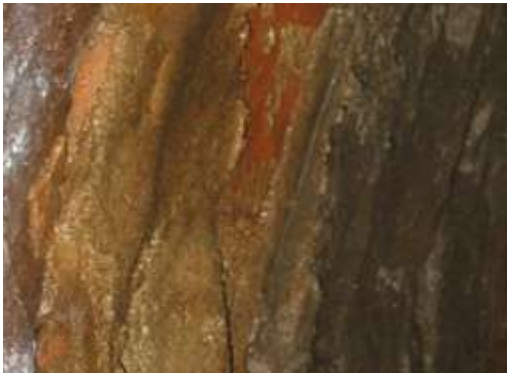
Infiltration: ☐ None ☐ Joint ☐ Cracks ☒ **Mortar** ☐ Roots ☐ Wall

mortar

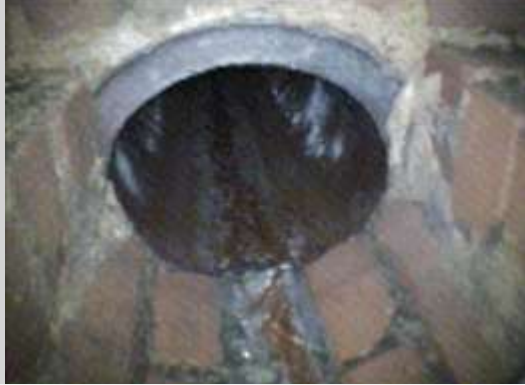
12 O'Clock Outflow

Pipe Height: **9.6** (in.) Rod and Bar (Angled)
Pipe Material: **Clay** ☐ Pipe Lined
Invert Depth: **12.66** (ft.) Flow Characteristics: **Fast**
Deposits: ☒ None ☐ Mud ☐ Sludge ☐ Debris ☐ Grease
Silt Depth: (in.) Deposits Extent:
Infiltration: **None** Pipe Seal Cond: **Sound**

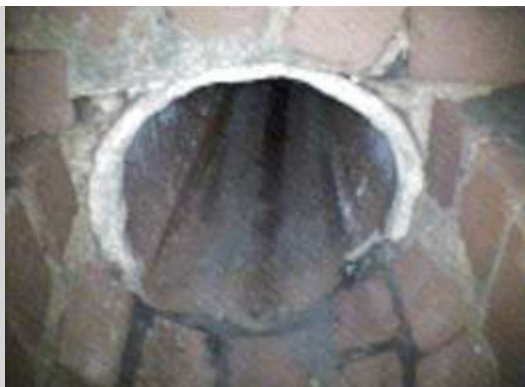
6 O'Clock Inflow

Pipe Height: **10.8** (in.) Rod and Bar (Angled)
Pipe Material: **Clay** ☐ Pipe Lined
Invert Depth: **12.66** (ft.) Flow Characteristics: **Fast**
Deposits: ☒ None ☐ Mud ☐ Sludge ☐ Debris ☐ Grease
Silt Depth: (in.) Deposits Extent:
Infiltration: **None** Pipe Seal Cond: **Sound**

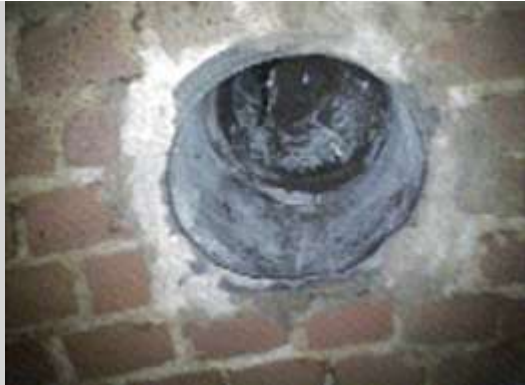
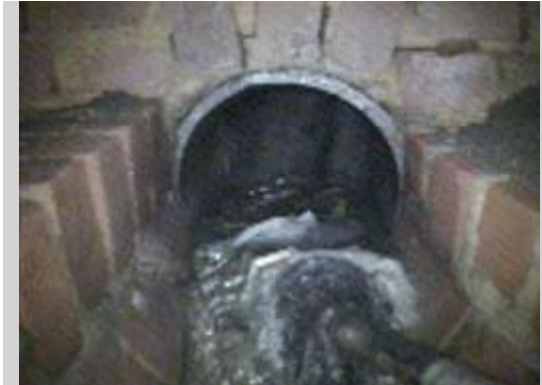
9 O'Clock Inflow

Drop: **Outside** Rod and Bar

Angled: **Yes** Reading: **11.50** (ft.)

Inv Depth: **12.50** (ft.)

Drop Condition: **Open**
